Experimental Investigation of Degradation and Non-Linear Effects in Corroded EMC Joints Exposed to High Power Microwaves (HPM)

FOI-R--1246--SE

Technical report

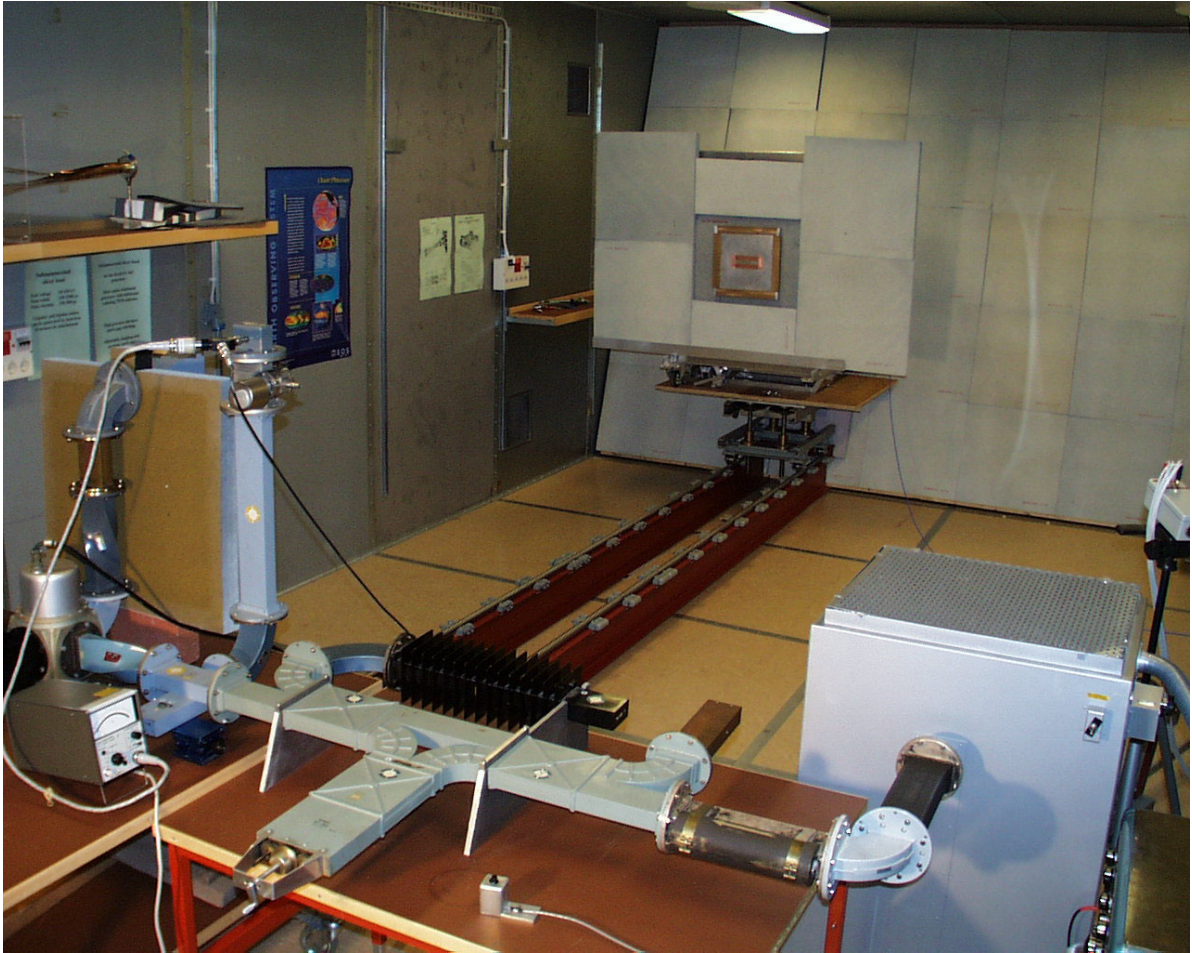
Figure 1. Measurement set-up. 700 kW, 3 GHz, magnetron to the right, transmitting horn antenna to the left. The aperture under test is mounted on a flange on the aluminum box “the kiosk”. In the picture the box is located on the rail at a distance of 4284 mm.

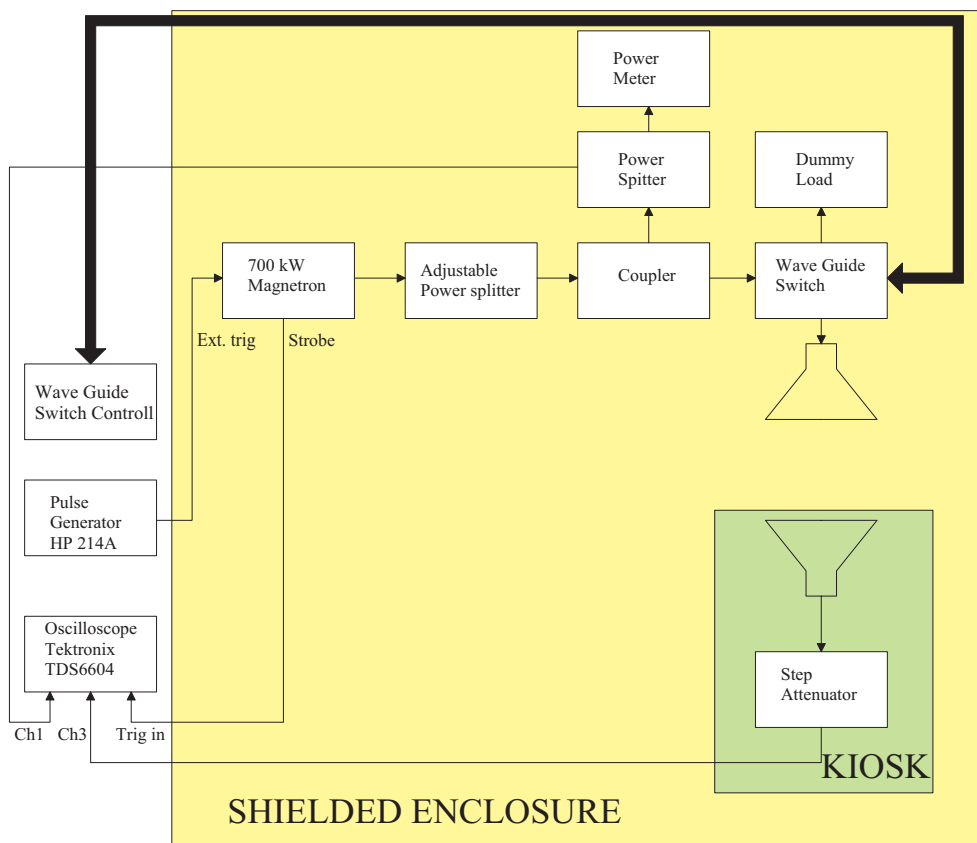
Figure 2. The measurement system. Block diagram

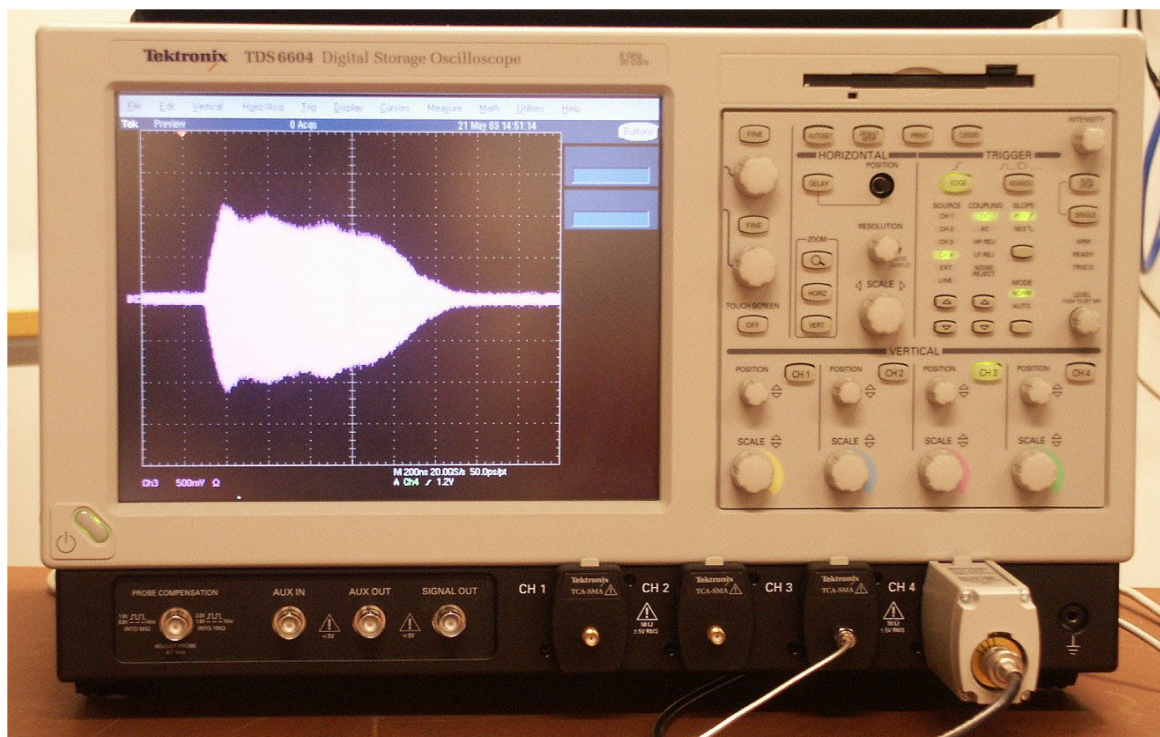
Figure 3. The 3 GHz, 1 μ s, output signal from the magnetron. 200 ns/div 20 GS/s 50 ps/pt 500 mV/div

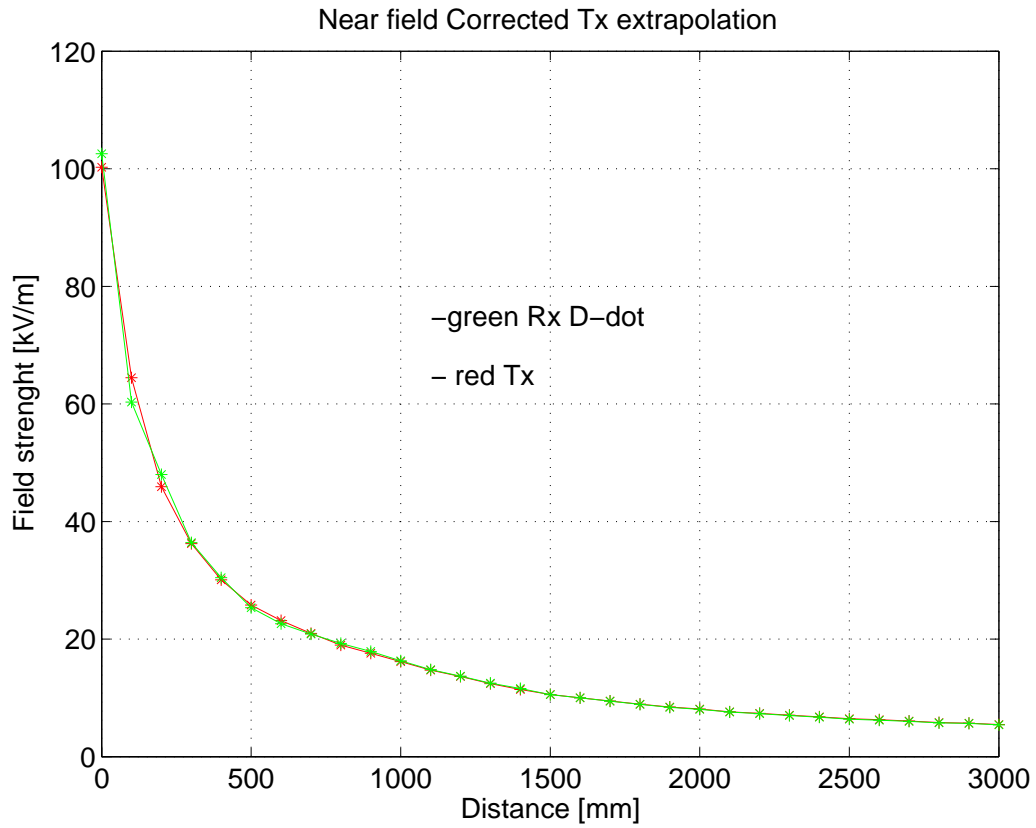
Figure 4. Typical field strength as function of the distance along the rail. Green curve measured using D-dot probe. Red curve derived from magnetron output signal.

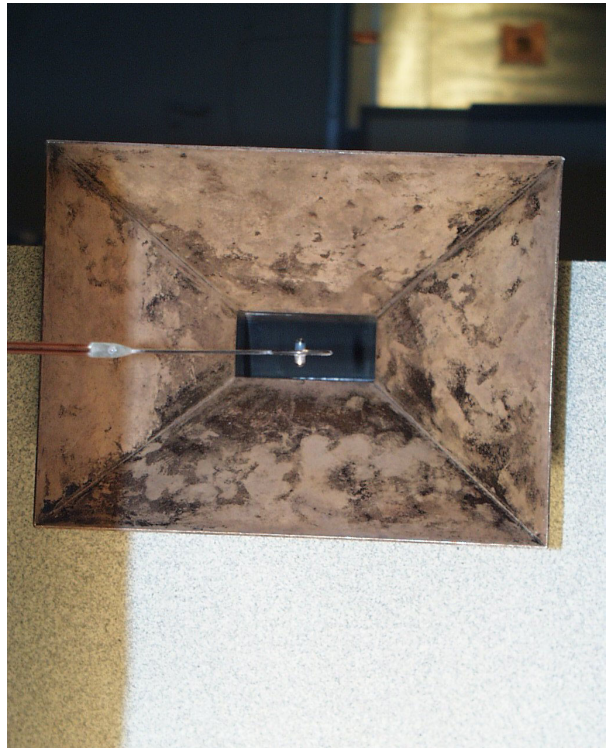
Figure 8. D-dot sensor and transmitting antenna viewed from the aperture under test.

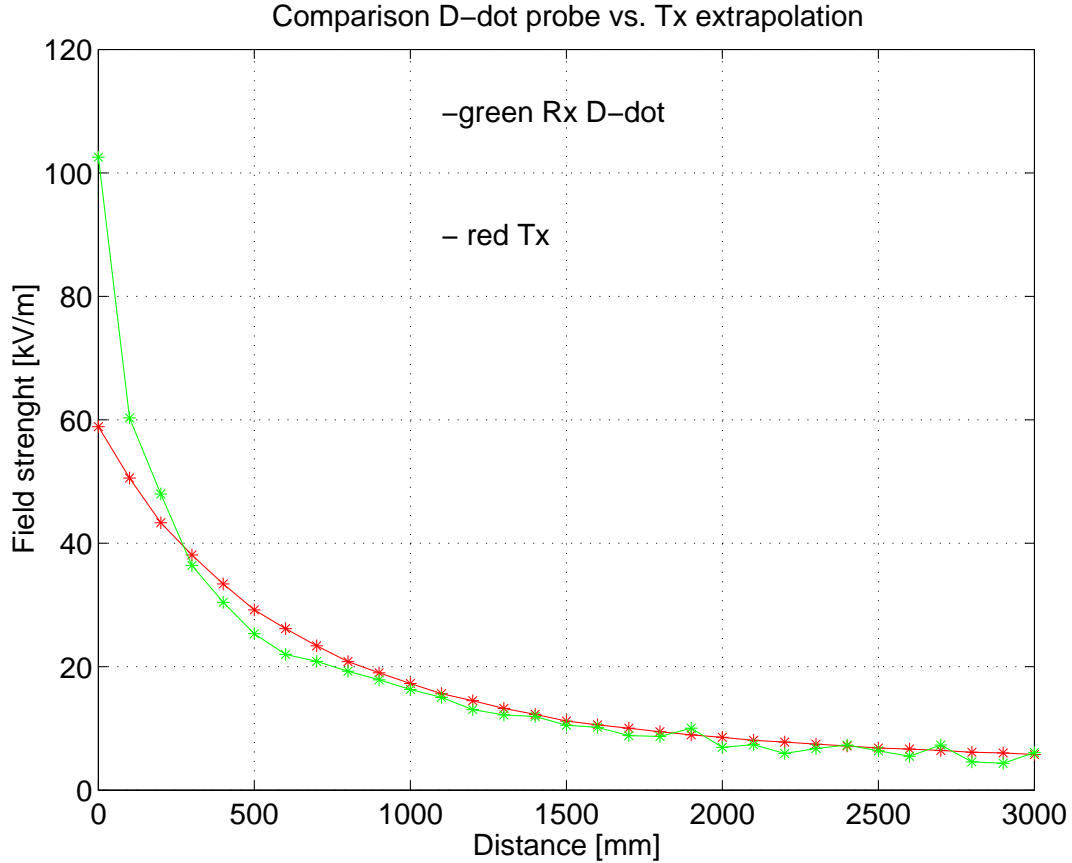
Figure 9. Comparison between the electric field strength measured by the D-dot probe (green curve) and the field strength calculated from a measurement using the receiving horn antenna (red curve). The latter calculation was made assuming a wave impedance of 377Ω .

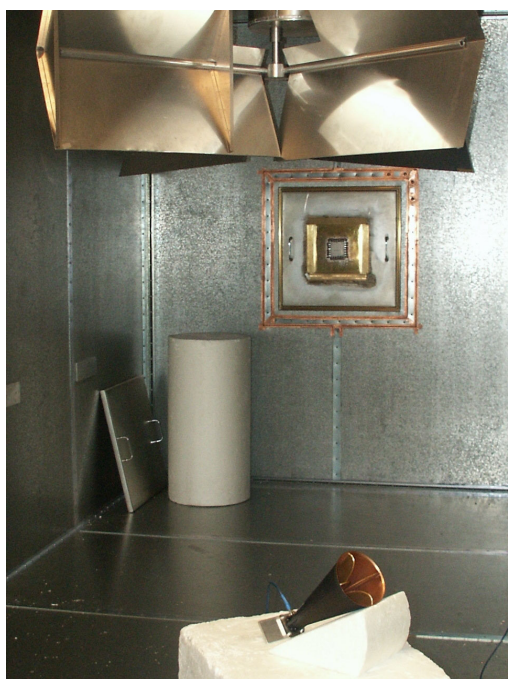
Figure 10. Measurement of aperture transmission cross-section in FOI reverberation chambers. Stirrer in the ceiling, receiving antenna in the front, fixture with test object mounted on a common panel between the two chambers.

Interiors from the reverberation chambers are shown in Figure 10 and Figure 11. More details about the measurements can be found in [8].

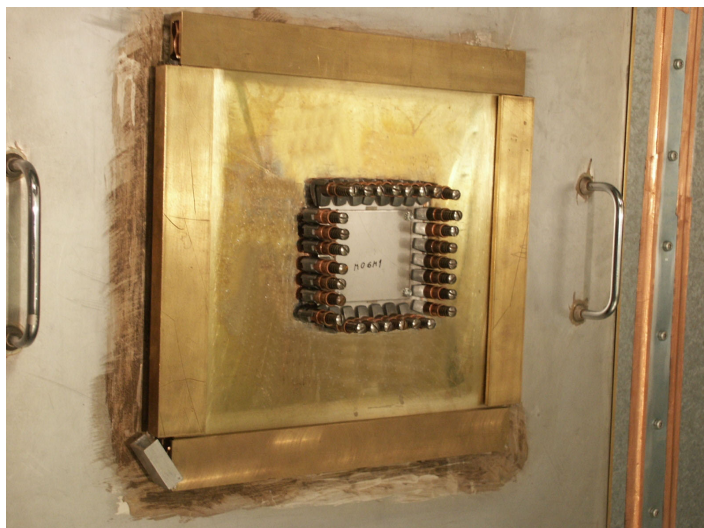
Figure 11. Aperture under test mounted in the reverberation chamber. A brass fixture covers a 290x290 mm opening between two chambers. The test object is mounted, using wave-guide clamps, over an 80x80 mm hole in the common panel brass fixture.

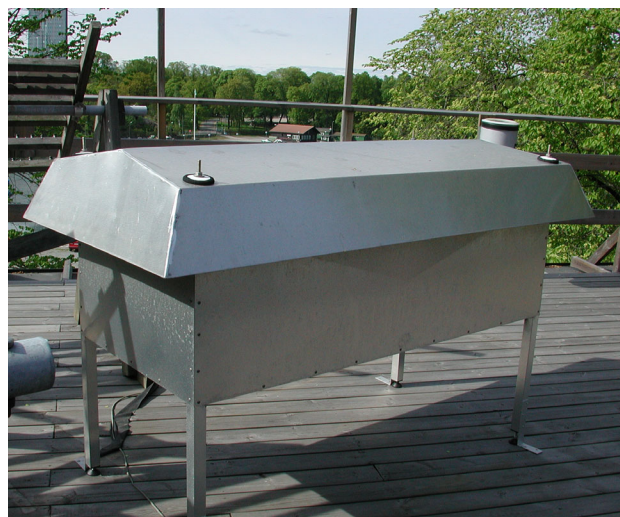
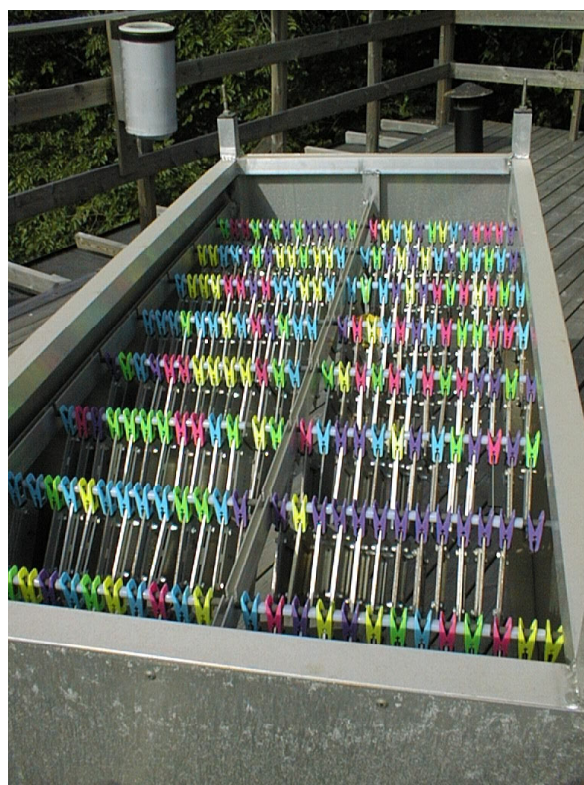
Figure 15. Outdoor exposure of the objects in the second study. The objects were exposed under a weather protective hood.

The second KI study comprised 58 different combinations of gasket and frame and cover plate. A complete description of the objects can be found in [8]. The matrix from which the 58 combinations were made is given in Table 1 below. Each combination was made in three samples, one of them using nylon screws and two using steel screws, see Figure 14 below. In our investigation 26 objects, all with nylon screws, were chosen. The choice was made so that the 26 objects yield a representative sample of the 58 combinations. Some objects were ruled out because of the limited dynamic range of the measurements of the transmission cross section in the reverberation chamber, the cross section of these objects were just too small. All 26 objects have been demounted after the exposure and then mounted together again. The designation of the 26 objects are: C0BJ, C0CF, C0HC, C0HK, C0KC, C0LE, C1BF, C1IE, C2BF, C2EM, E0IE, E0LE, F0CF, F0GF, M0EM, M0GM, N0CF, N0FK, N0GM, N0IE, N1IE, N1IP, N3DF, N3EF, N3EM, N3IE. Six of the chosen objects showed a large change in shielding after the outdoor exposure, namely C0BJ, C0CF, M0GM, E0IE, N0IE and N3IE. The designation of the objects is defined in Table 1 below. A drawing of the geometry of the test objects is given in Figure 14. The objects have been exposed for one year, 2002-07-05 to 2003-07-28, under a hood on a terrace close to a lake, immediately north of the Stockholm city boundary (Kräfriket), see Figure 15 and [8].

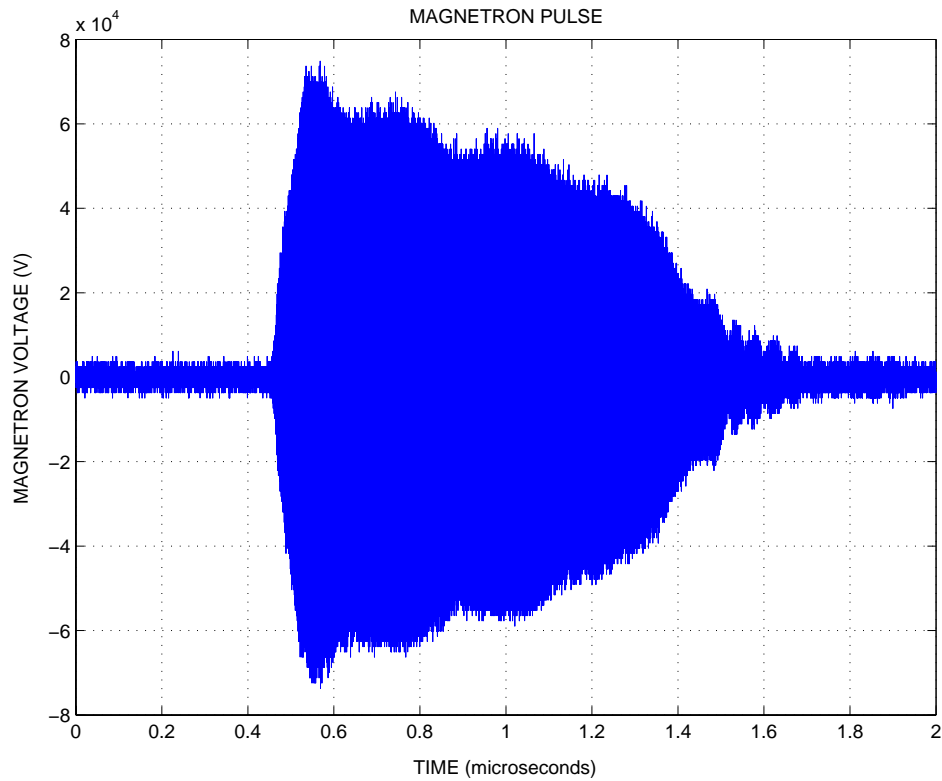
Figure 16. Pulse from magnetron measured in the reference port. Time-domain.
UL_100_040112, first pulse.

The shape of the magnetron pulse, measured in the wave-guide, varies slightly between pulses. An example of the pulse, in the time-domain, is shown in Figure 16. The frequency spectrum, obtained by applying the MATLAB FFT, of the same pulse is shown in Figure 17. In this case, contrary from the measurements below using the D-dot probe, we just apply the FFT on the voltage signal from the probe in the wave-guide. As can be derived from the spectrum the peak value of the 6 GHz component is about 36 dB below the peak value of the main peak at 3 GHz. A measurement of 10 spectra shows yields the value 35.6 ± 0.6 dB. The corresponding pulses in time-domain are shown in Appendix B.

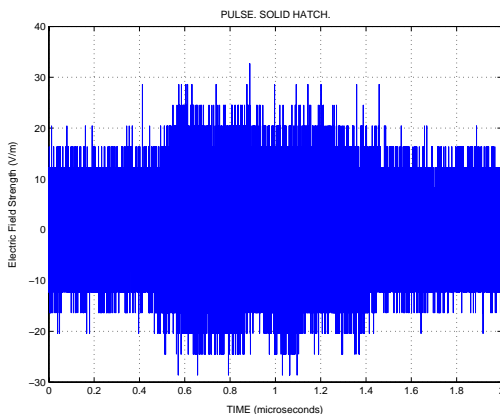
Figure 20. Pulse measured in test box with solid hatch. Distance 500 mm. Time-domain. Solid_pytte_06_500_050225, first pulse.

When the AUTs were replaced by a solid plate almost no signal at all could be detected. This assures that the detected signals in the actual tests really have their origin in leakage through the AUT's and are not caused by leakage between the surfaces connecting the AUTs to the flanges of the test setup.

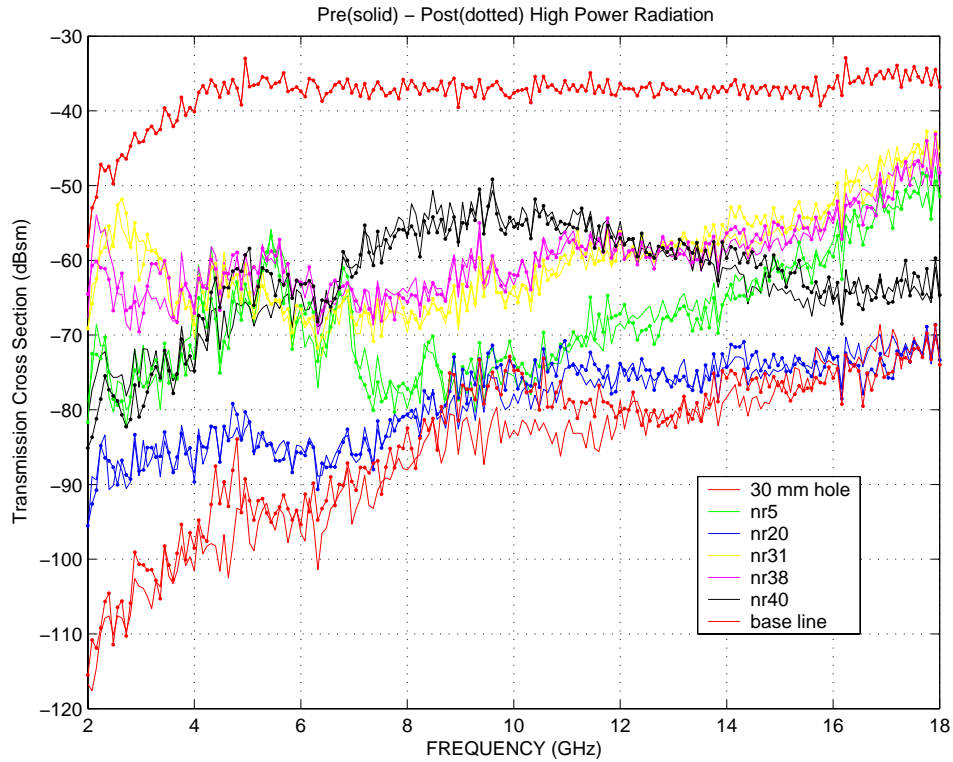
Figure 24. Transmission Cross Section of the five test objects subjected to accelerated ageing measured before and after the exposure to the high field levels. The upper curve, 30 mm hole, is included for reference. The lower curve (red) is measured using a solid hatch.

In order to evaluate possible damage or degradation of the shielding joints the cross-sections were measured both before and after exposure to the high field levels. The measured transmission cross-sections before and after the high-level radiation are shown in Figure 24. In the figure two reference curves are included. The upper curve shows the transmission cross section for a 30 mm diameter circular hole. This was used as a reference for deriving the absolute values of the transmission cross sections of the test objects, cf. paragraph 2.2. A solid hatch, the lower red curve, has been used to establish the measurement floor, i.e. it shows the cross section corresponding the unwanted leakage around the edges of the test objects. A plot of the differences is shown in Figure 25. As can be seen in the plot it is difficult to see any systematic changes after the irradiation. The differences for the test objects are not greater than the variation for the solid hatch (which has not been subjected to any high level irradiation). This conclusion holds also for object 38, which is the only object for which a distinct non-linear process could be detected (that happened only in one of the runs), see next paragraph.

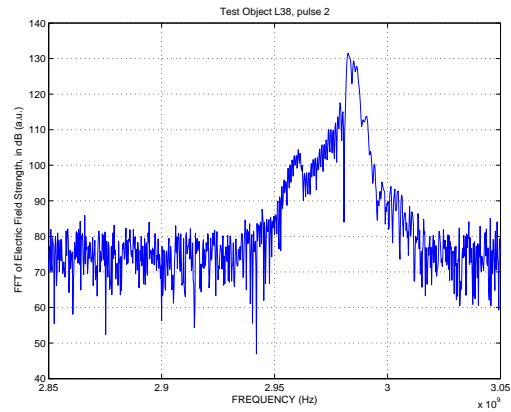
Figure 26d. Pulse transmitted through test object L38. Distance 200 mm. Pulse 2. $E = 38$ kV/m. Frequency Domain, between 2.85 and 3.05 GHz.
L38_200_031218.

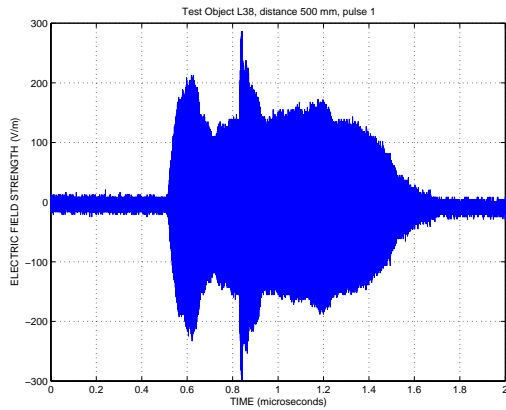
Figure 27a. Pulse transmitted through test object L38. Distance 500 mm. Pulse 1. $E = 21$ kV/m. Time Domain. L38_500_031218.

However, it is interesting to note that in one case, object 38, distance 500 mm, pulse 1, there is a marked distortion of the pulse in the time domain, see Figure 27a. (It shall be reminded that the existence of strong non-linear effects means that the calibration factor used in the time domain plots may not be exactly correct, see paragraph 2.3.1.). The frequency plot around 6 GHz is shown in Figure 27b. The peak at 6 GHz is only 44.6 dB below the peak at 3 GHz. The frequency plot around 0 Hz is shown in Figure 27c and the plot around 3 GHz in Figure 27d. It is clearly seen that the plot around 0 Hz shows a much stronger variation with frequency, i.e. the slope is steeper, compared to the other cases (see e.g. the plots for the open and closed hatch in Appendix C). In Appendix D we present plots using a logarithmic frequency scale. This makes it easier to distinguish between the 20 dB per decade slope that has its origin in the compensation for the $1/f$ -dependence of the D-dot probe, making a 20 dB/decade slope of the background level, and a genuine envelope detection. In those plots one can clearly notice a difference between the distorted pulse for object 38 (distance 500 mm, pulse 1) and the other pulses. In most of the latter cases there is a steady 20 dB per decade slope all the way down to 0 Hz. This is not the case for object 38, pulse 1, at the distance 500 mm, where we can see a shift in the slope towards lower frequencies. Also L38, pulse 1, at 200 mm shows this behavior although less pronounced. As can be seen in Figure 27 (and in Appendix D) the amplitude of the frequency spectrum for L38 (pulse 1) at 200 mm distance at 0.25 MHz is about 65 dB higher than the amplitude for the 3 GHz peak. Although the peak at 3 GHz is much broader it indicates that a lot of energy may have been shifted towards lower frequencies. Some preliminary analyses based on an integration of the time domain data (the D-dot probe is derivative) indicate that the level of the signal due to envelope detection may even be larger than the 3 GHz signal. These conclusions are however very uncertain and the matter should be further evaluated in the future. As noted earlier the uncertainty of the analysis of the low frequency content is due to the low sensitivity of the D-dot probe at low frequencies.
